Case Study on Cabana Bar Grease Trap Utilising Aquatemp Enzyme Dosing Treatment

Location: Southport Australian Football Club, Cnr Musgrave & Olsen Avenues, Southport 4215, Queensland

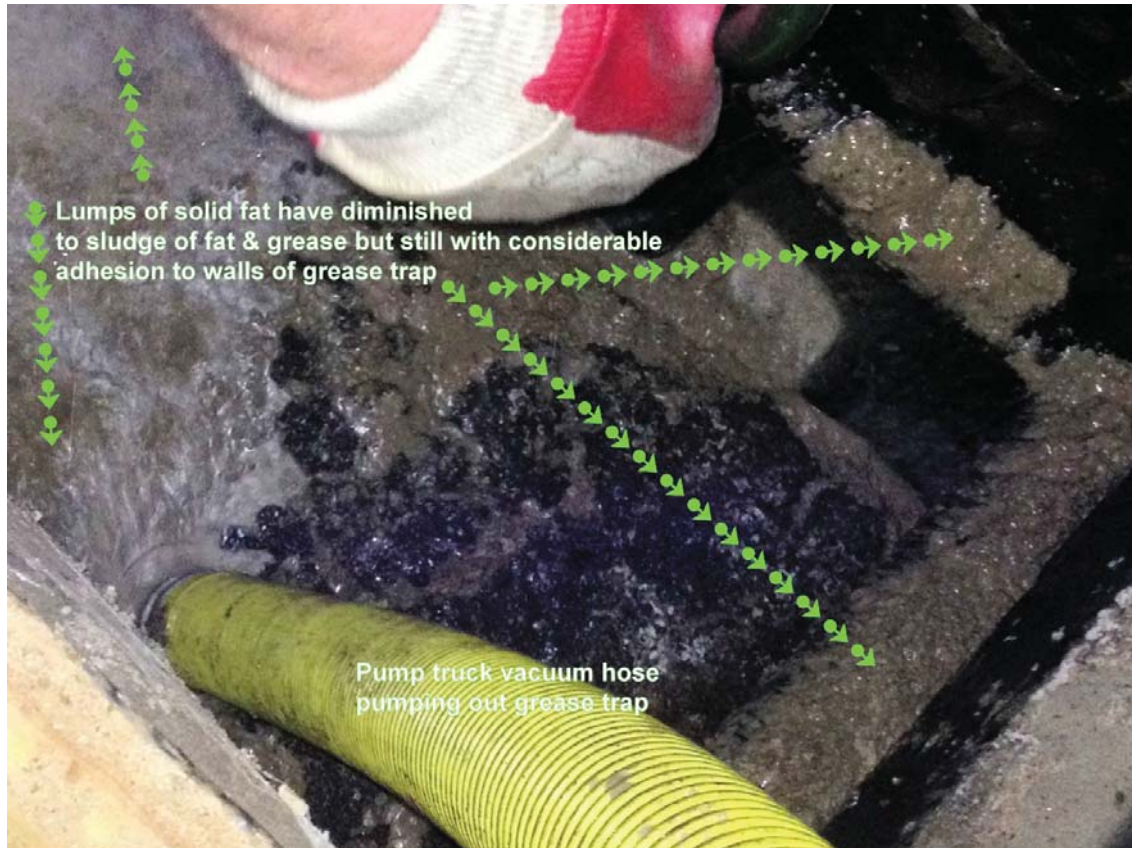
Grease Trap 17 July

All Southport Sharks grease traps are pumped out monthly and the photos below are of the grease trap after 10 days of manual dosing.

The first pit still had considerable solid fats but the odour issues were nowhere near as bad as on 8 July and as can be seen the fats were not in large lumps.

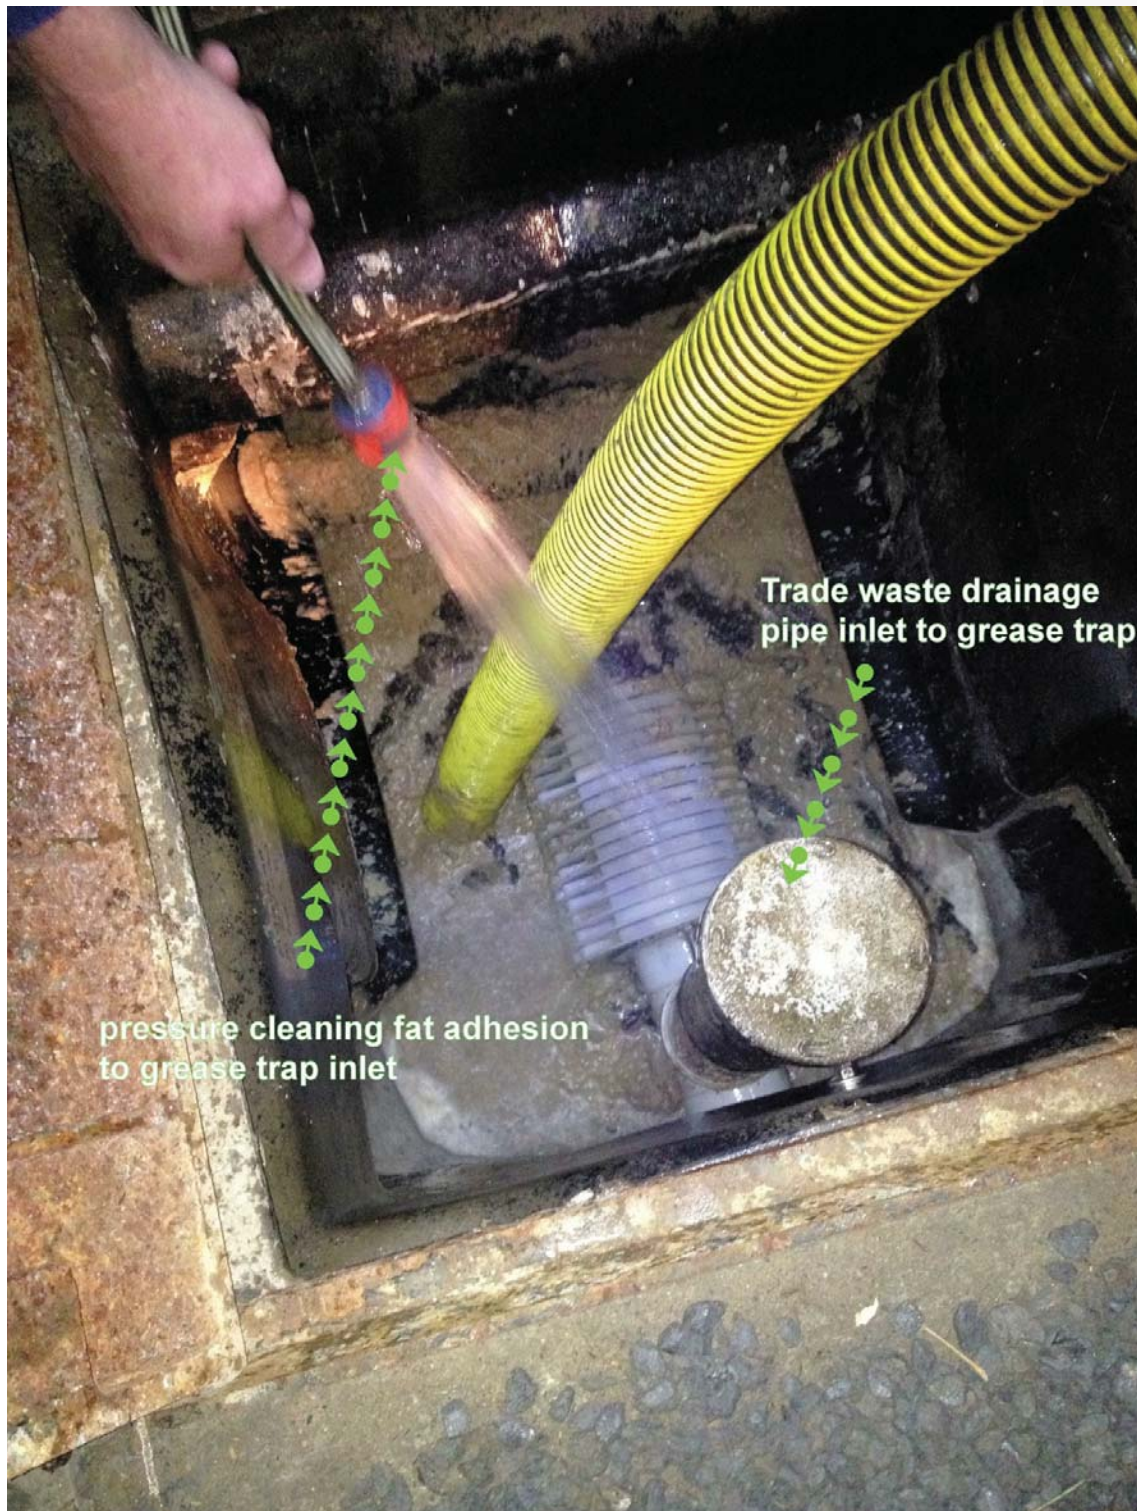
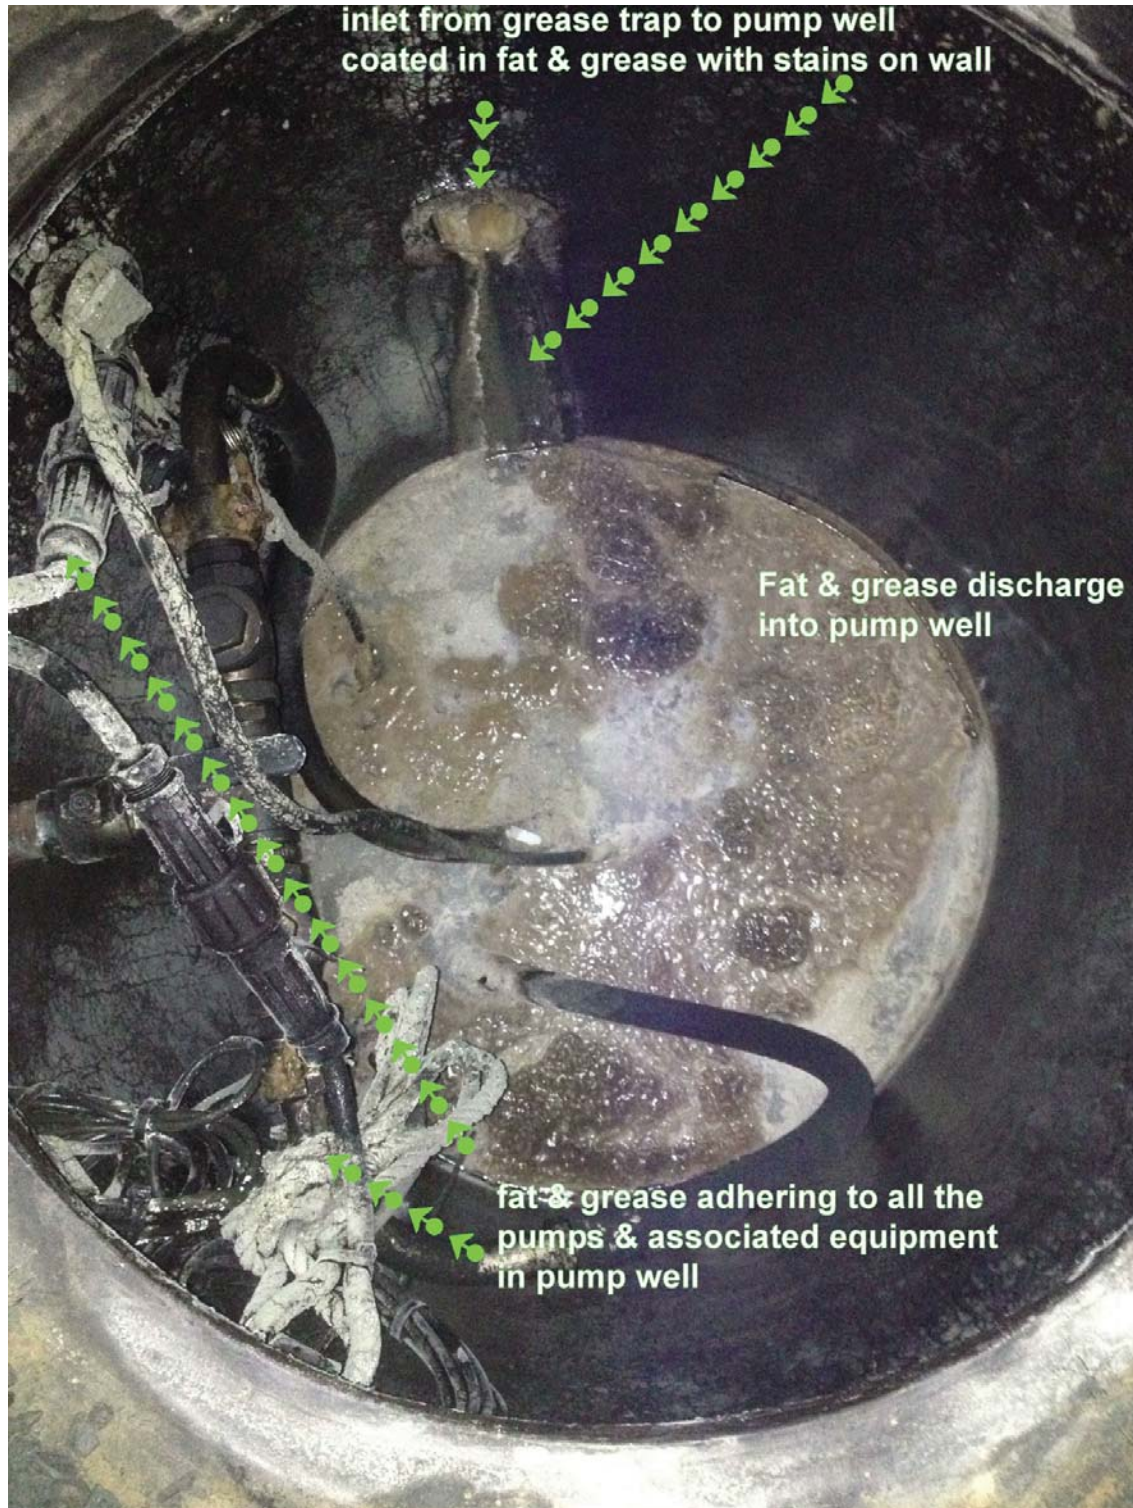
The pump well photo below still has far too much fat and grease being discharged into it which will affect the pumps operationally and with life expectancy plus discharging grease into the pipe lines which is causing odour issues inside the club.

As can be seen there is constant flows down the inlet which is also adhering to all the working parts in the pump well.

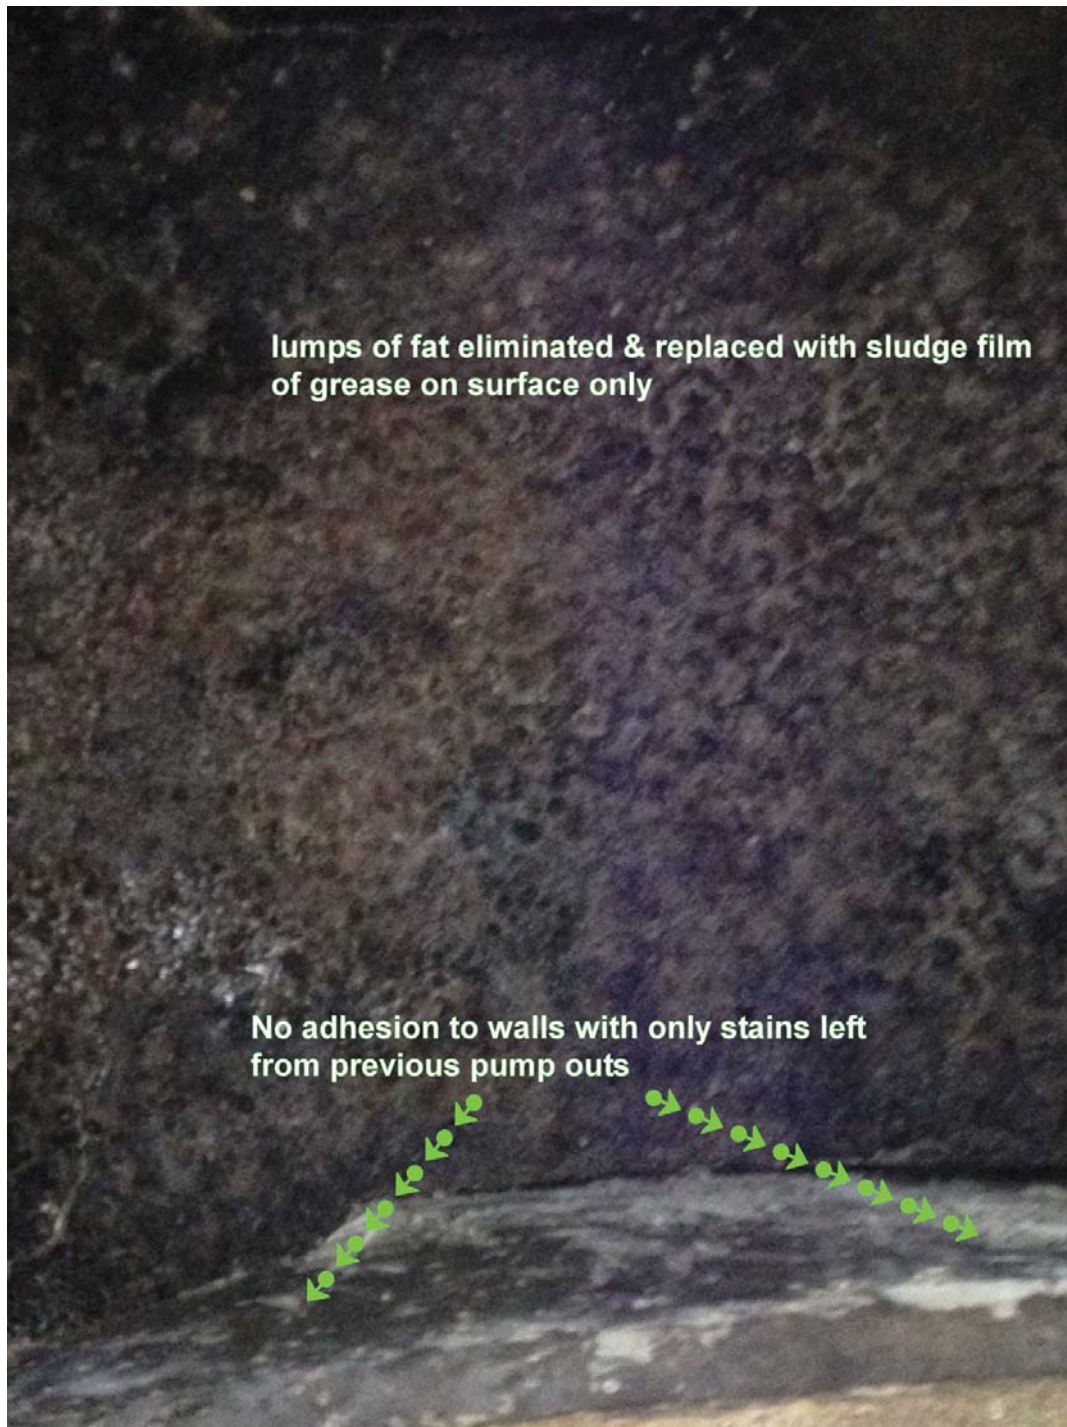
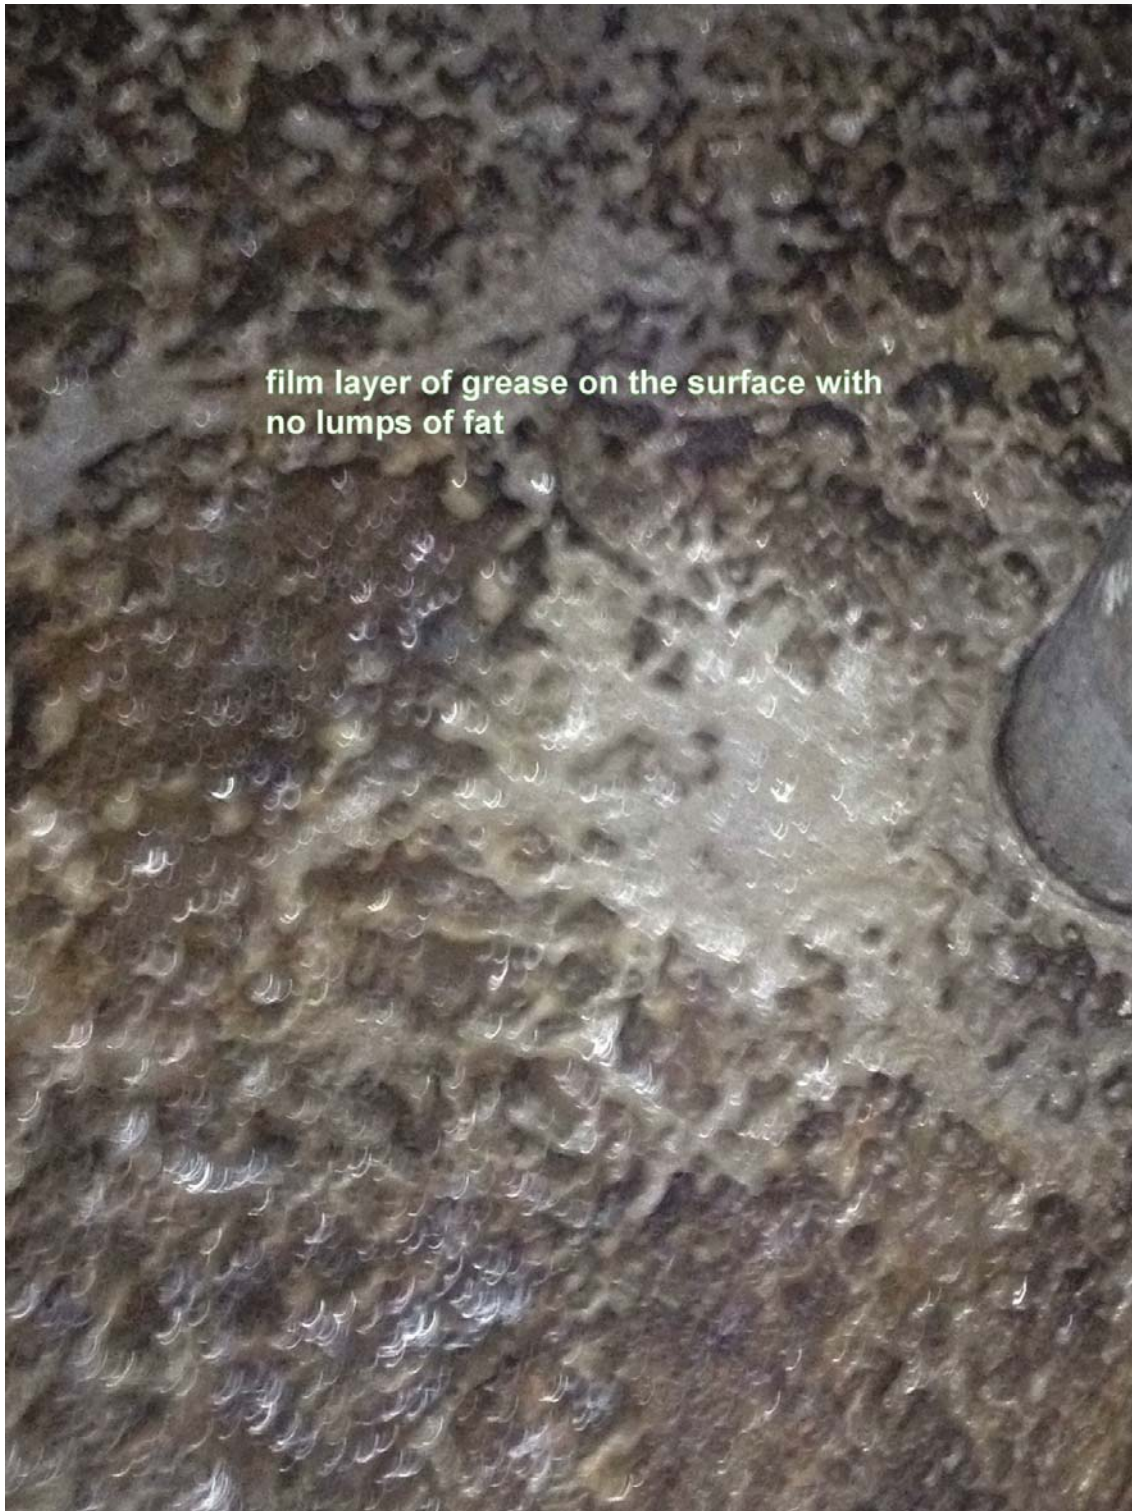
Grease Trap 14 August

On 14 August the monthly pump out was due and the photos below show a marked change in the fats and grease with there being little solids and there only being a film of grease on the surface. Plus there was virtually no odour and for the first time all three lids could be opened at the same time.

Manual dosing of the grease trap continued until 11 September when it was replaced with an automated monitoring and dosing unit installed under the bar sink. This unit automatically releases 300mL every day at 2.30am into the trap system under the bar which then flows through to the grease trap.
