YeppoonCentral

shopping centre

ZeroFlush Waterless Urinals Condition & Servicing Report

8 November 2013

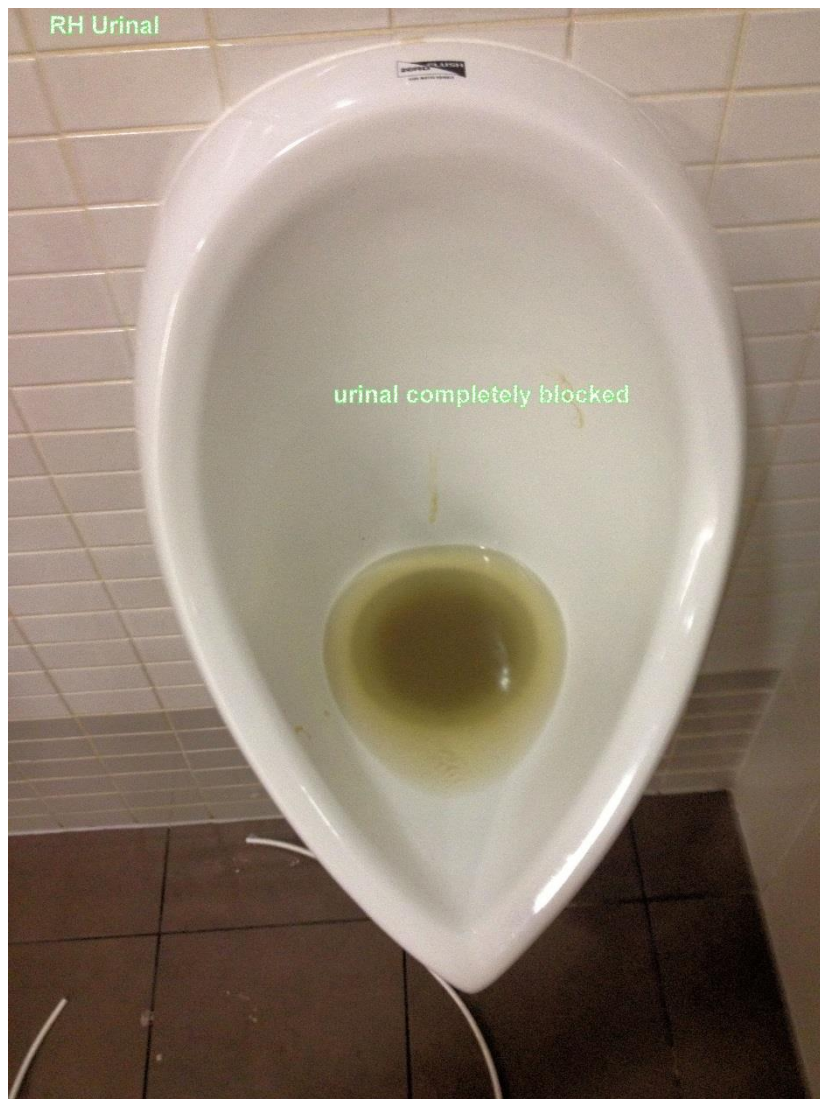
The urinals were in an appalling condition with the odour permeating from the male toilets into the surrounding corridor area. All three urinals were blocked to varying degrees and were for all intensive purposes unusable.

As can be seen from the above photo of the RH urinal after removal of the insert there was no odour barrier oil in the urinal and the drain was completely blocked.

All three urinals were completely cleaned up as follows:

- drains cleaned and cleared out using a hand held drainage eel and water to ensure that the drains were running freely
- the housing completely scrubbed clean using a hard bristle brush which enabled the uric salt adhesion to be easily removed from the ABS plastic housing plus pouring water down to ensure the salts washed through the drains
- the stainless steel ring was completely cleaned and polished using 3M stainless steel cleaner and polish in conjunction with Scotch-Brite multi-flex abrasive sheets which brought the stainless steel back to a near new condition

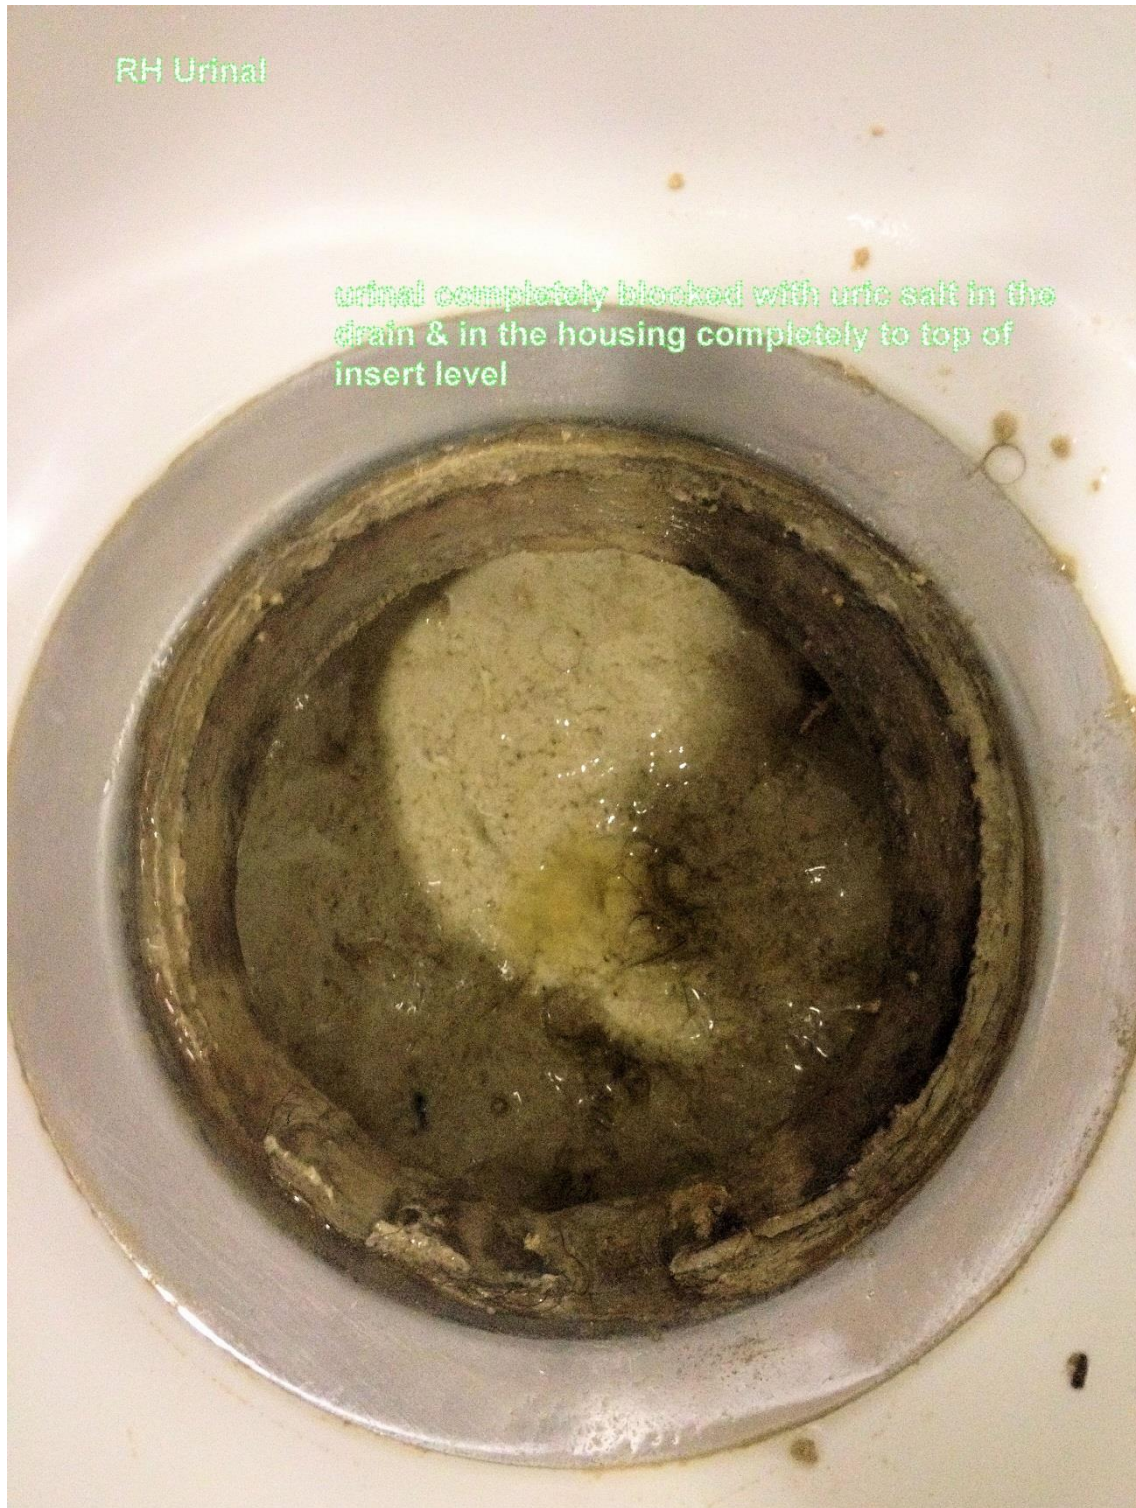
Using plastic hose through the drain out let enabled the urine to drain leaving behind a housing full of uric salt that extended completely to the top caking the sides as can be seen in the above photo.

All three urinals were in exactly the same state with solid crusts of uric salt adhering to the ABS plastic housing and to the stainless steel ring at the top. The inserts were completely coated also with their trapping systems almost non-existent.

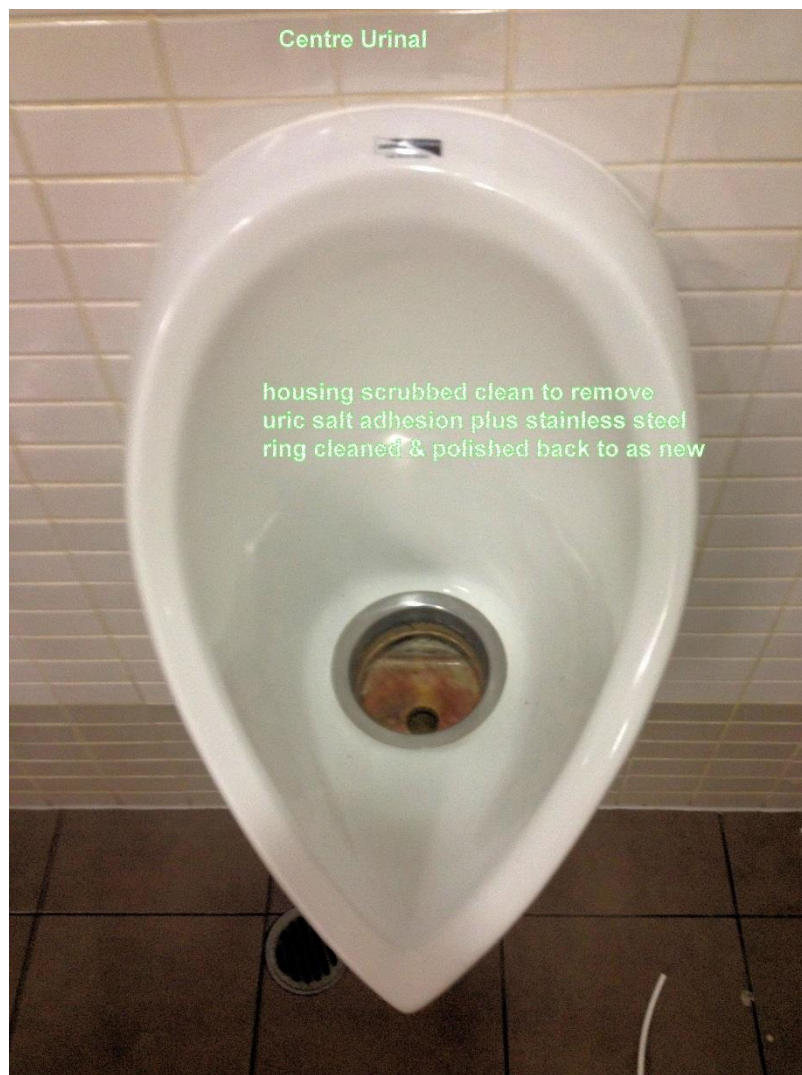
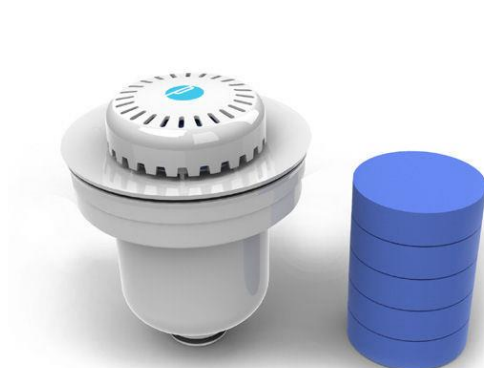
All three urinals were then fitted with white EnviroSeal operating systems that utilised BioPur enzyme kits composed of specially formulated bacterial cultures capable of degrading uric acid salts, the leading cause of odours in all urinals.

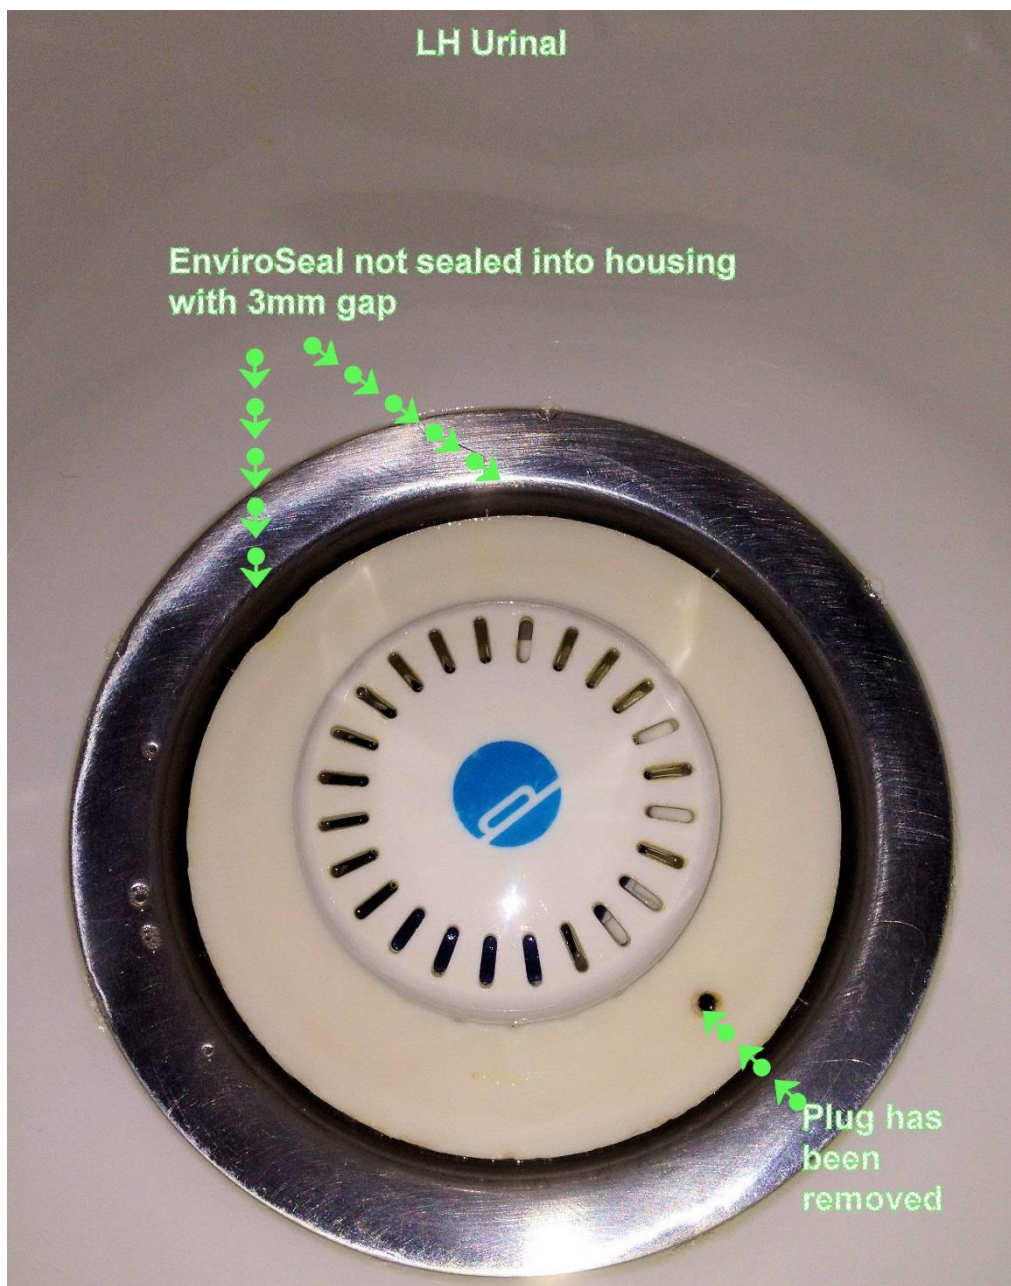
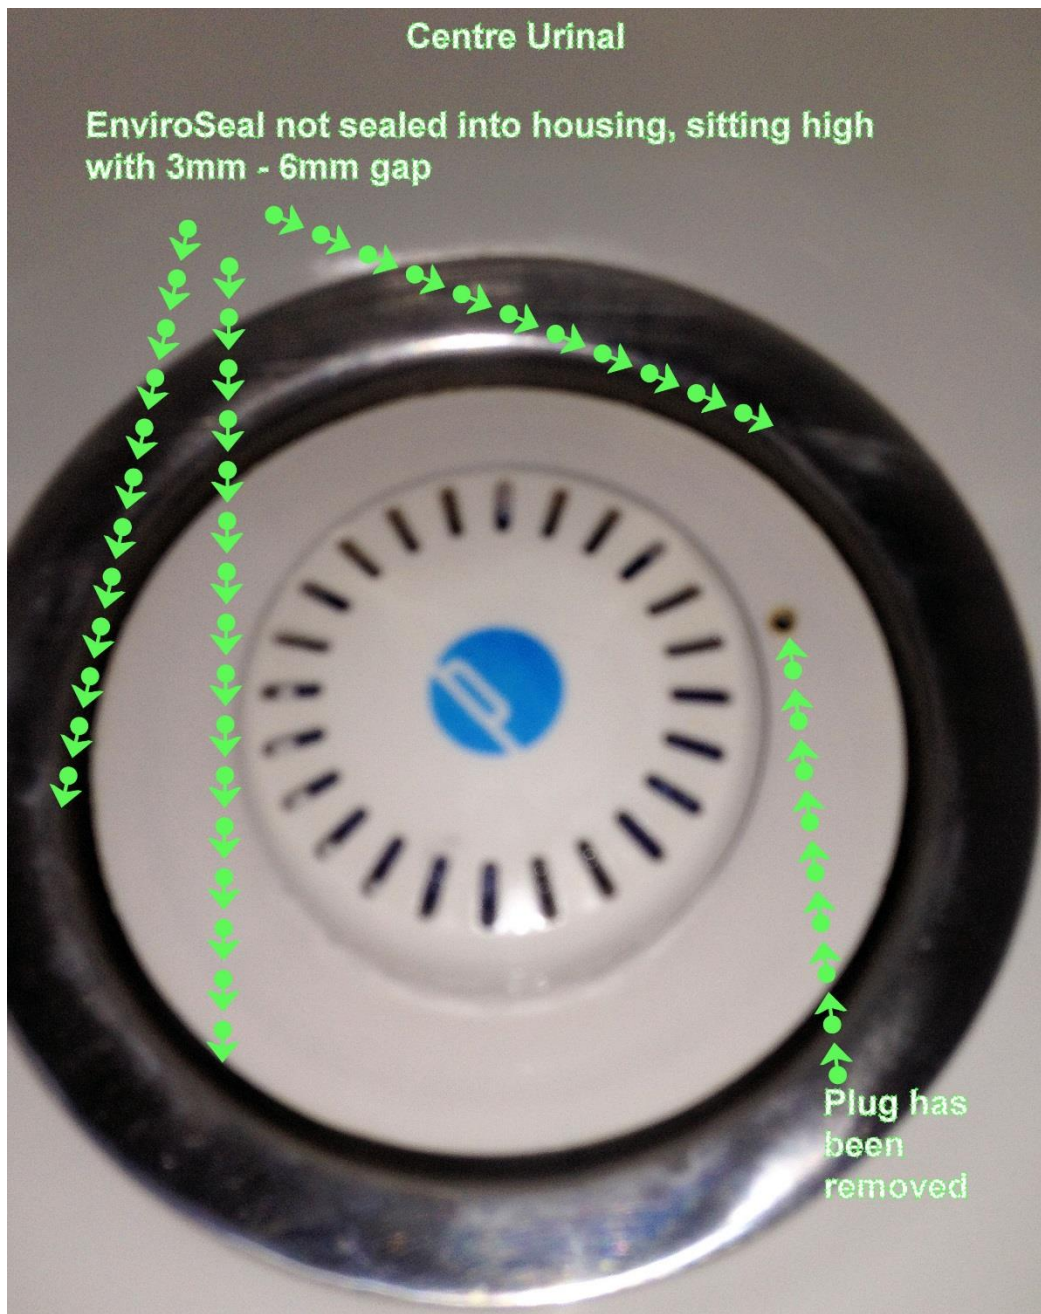
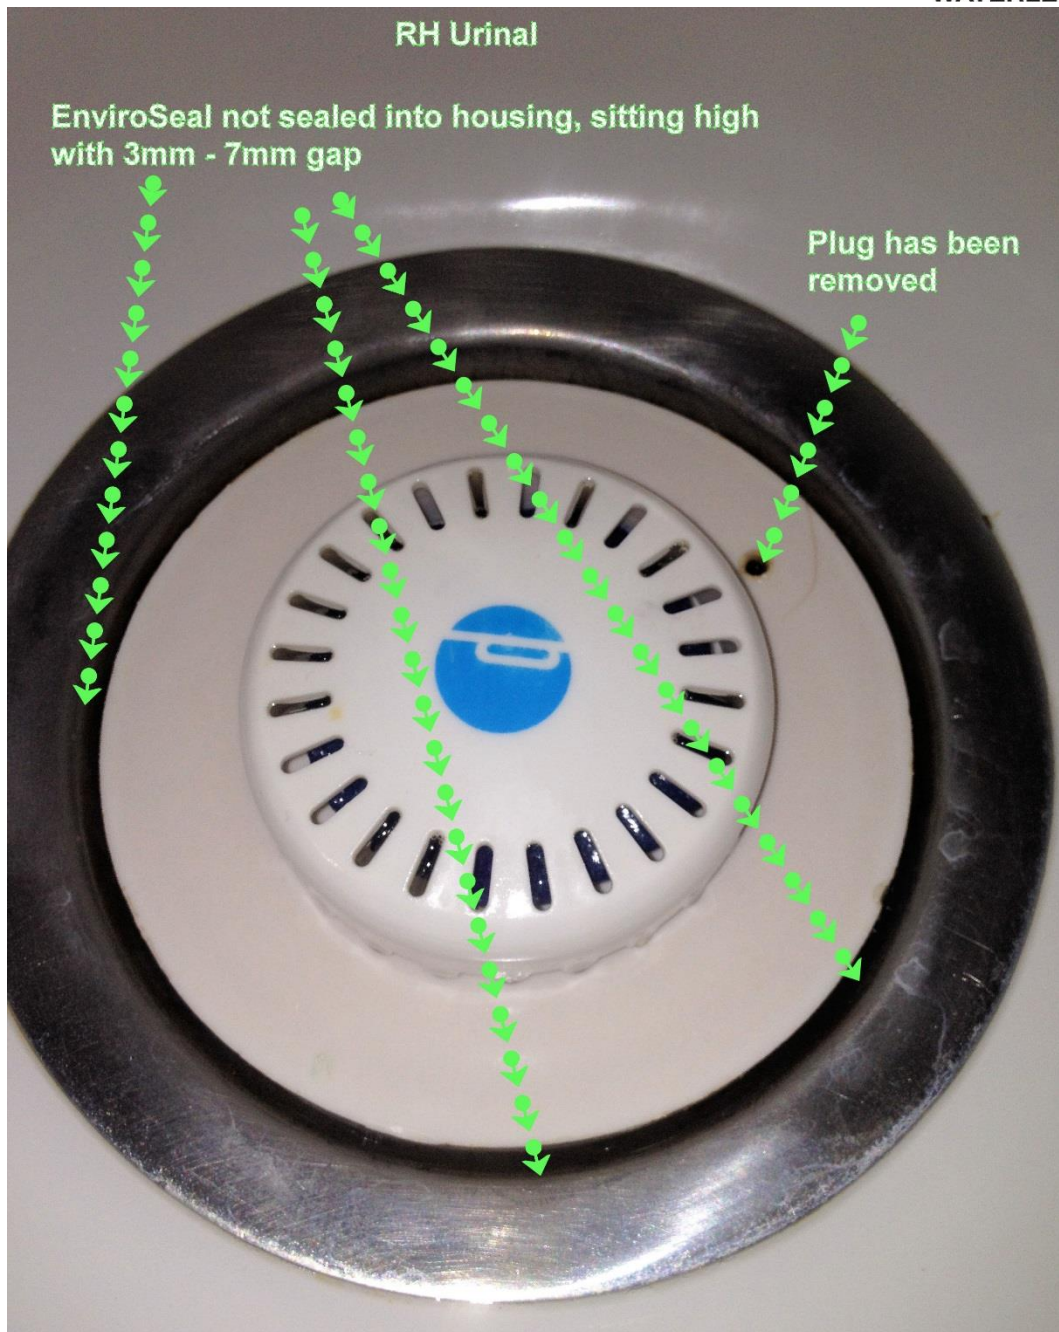
The problems with the odour were obvious as all three urinals were emitting sewer gases into the male toilets as the EnviroSeal units had all been removed at some time and not reassembled correctly. Every urinal was not sealed into the stainless steel ring as per the attached photos plus the top and bottom of the EnviroSeal had been unlocked with the top just sitting in the urinal.

Also every EnviroSeal had obviously been removed from the urinal by pushing out the side plug rather than through the centre access hole under the BioPur kit holder. This resulted in the plugs being lost and had never been replaced.

- Do not let anyone remove the EnviroSeal units from the urinals as there is no need for them to be removed if the cleaning is being undertaken correctly and the enzyme gels being replaced at intervals not exceeding 2 months

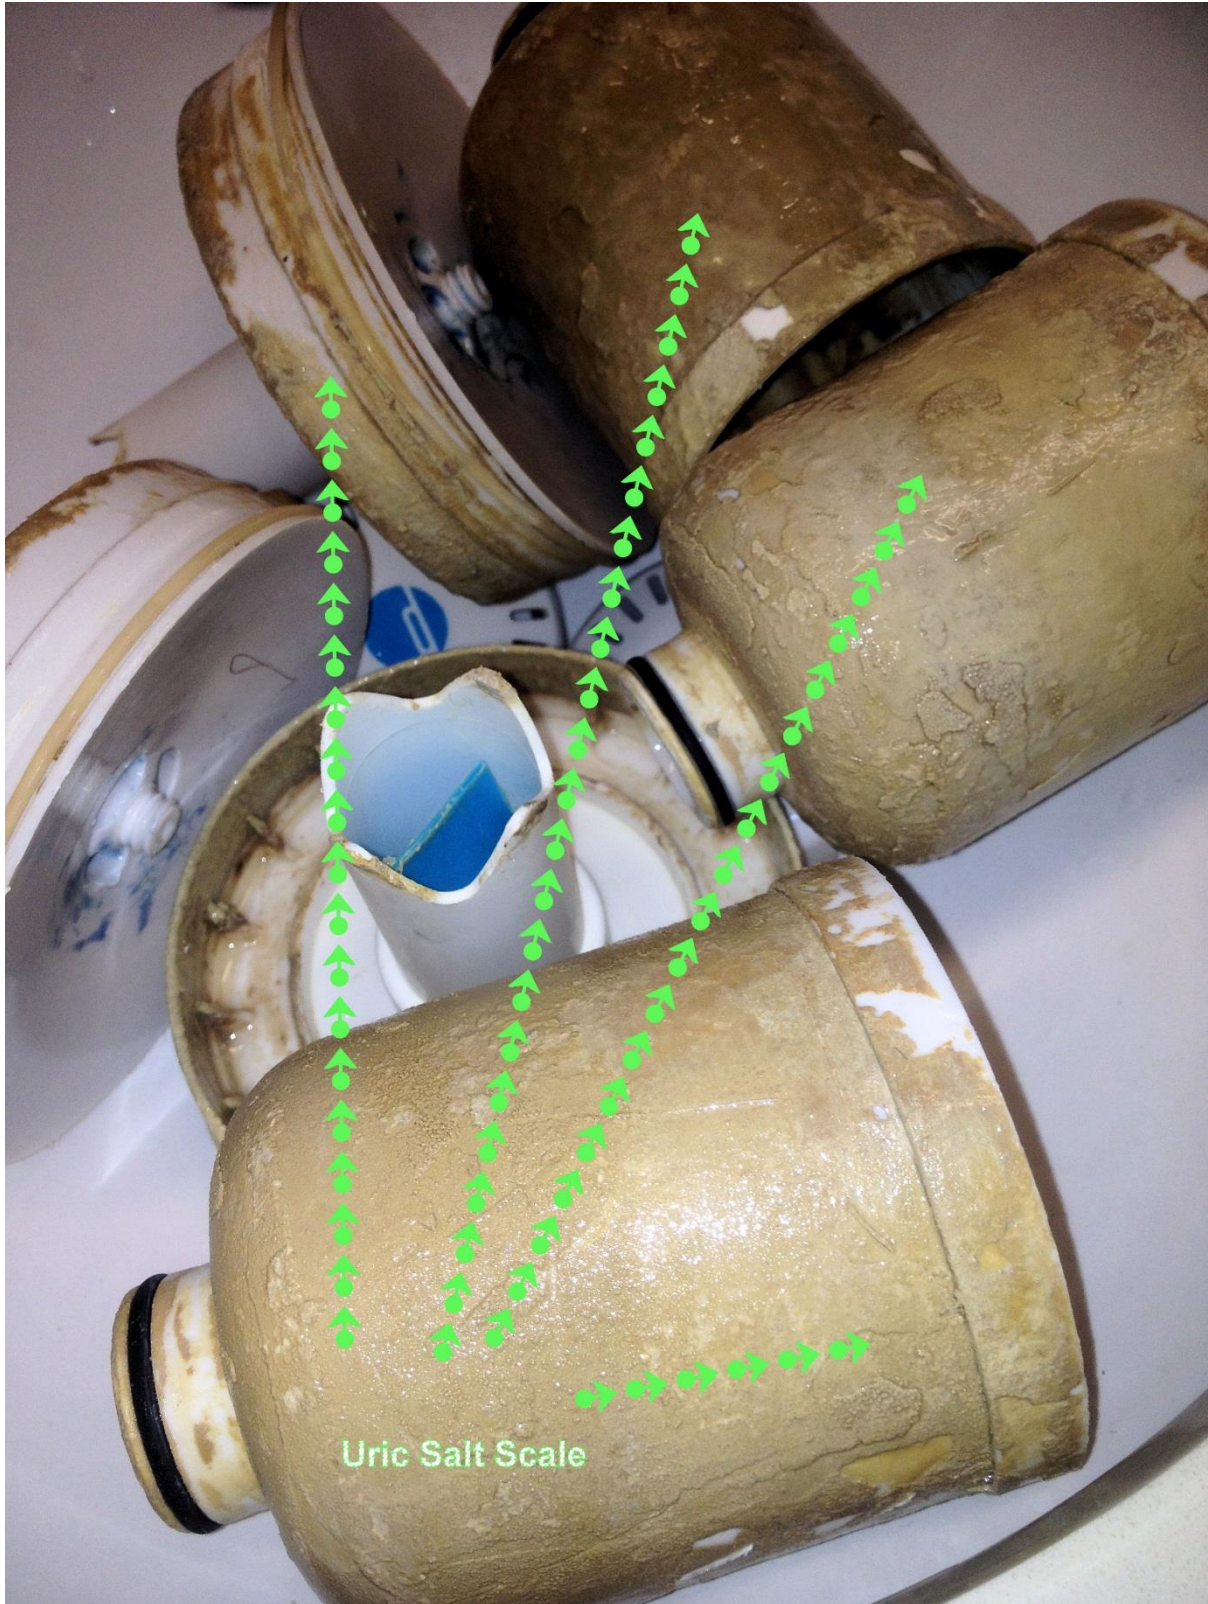
As a result of all of these issues there was no seal at all allowing urine to fill the urinal housing and then overflow down the drain. This had resulted in uric salt scale adhering to the outside of the EnviroSeal units in the housing which was everywhere and had hardened to such an extent it was extremely difficult to remove as can be seen in the photo below.

Once again all three urinals were completely cleaned up as follows:

- drains cleaned and cleared out using a hand held drainage eel and water to ensure that the drains were running freely with two large lumps of mortar being removed from the drain on the centre urinal
- the housing completely scrubbed clean using a hard bristle brush which enabled the uric salt adhesion to be easily removed from the ABS plastic housing plus pouring water down to ensure the salts washed through the drains
- the stainless steel ring was completely cleaned and polished using 3M stainless steel cleaner and polish in conjunction with Scotch-Brite multi-flex abrasive sheets which brought the stainless steel back to a near new condition

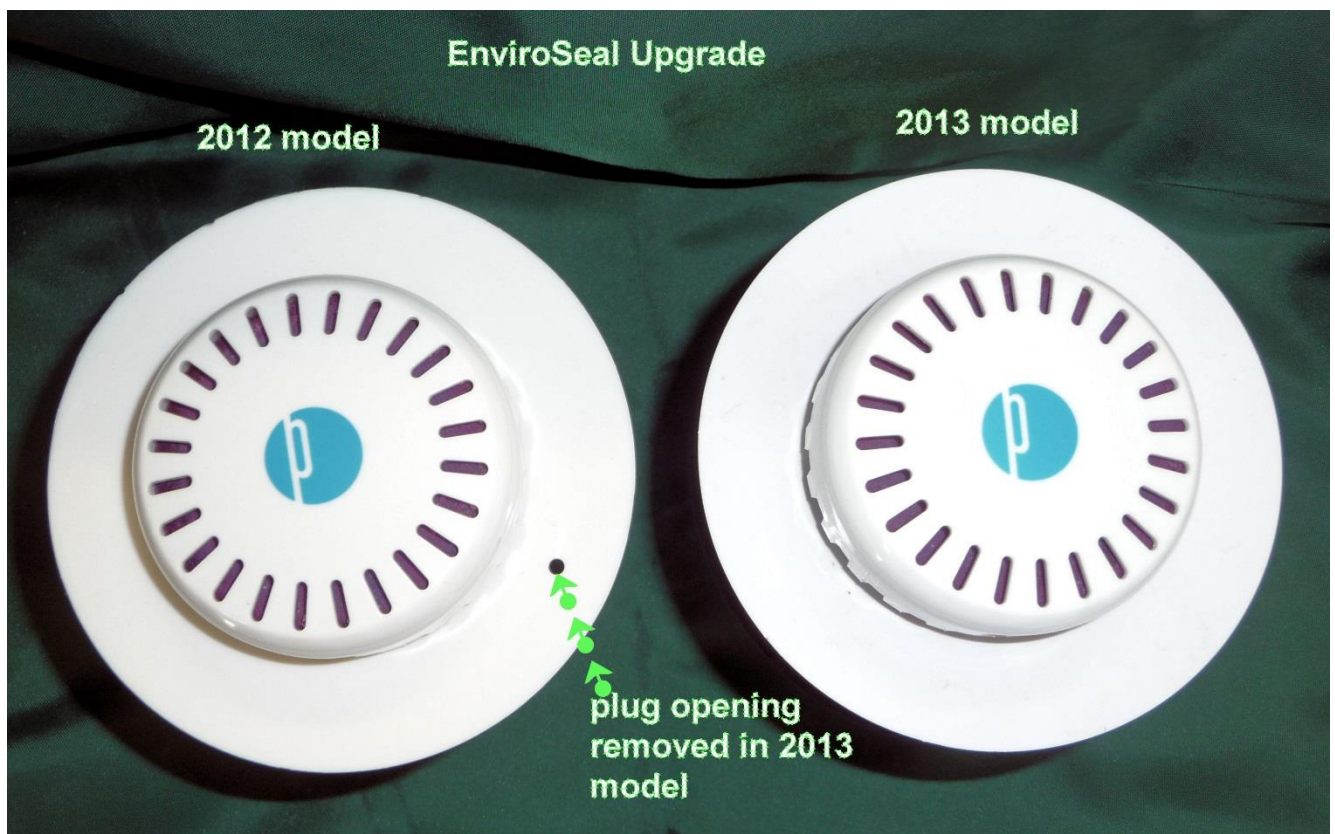
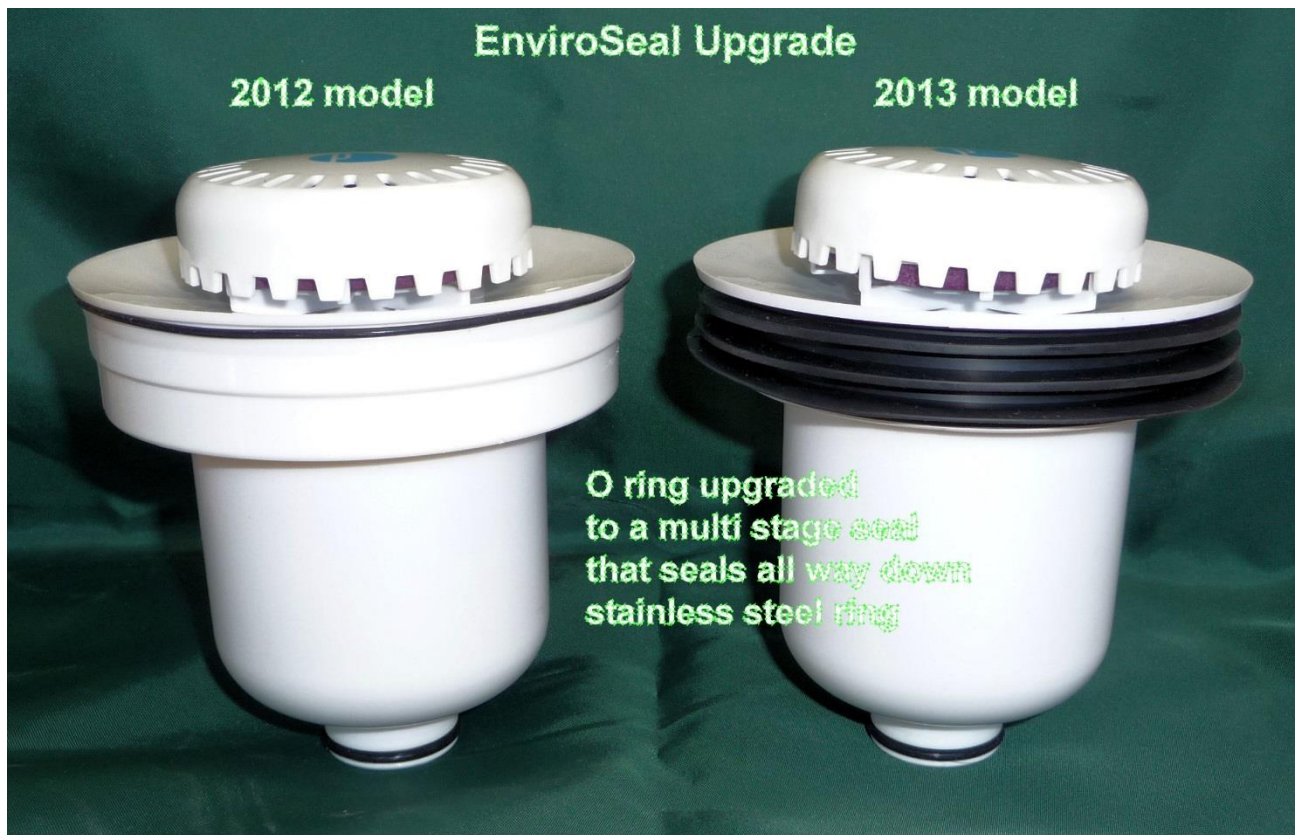
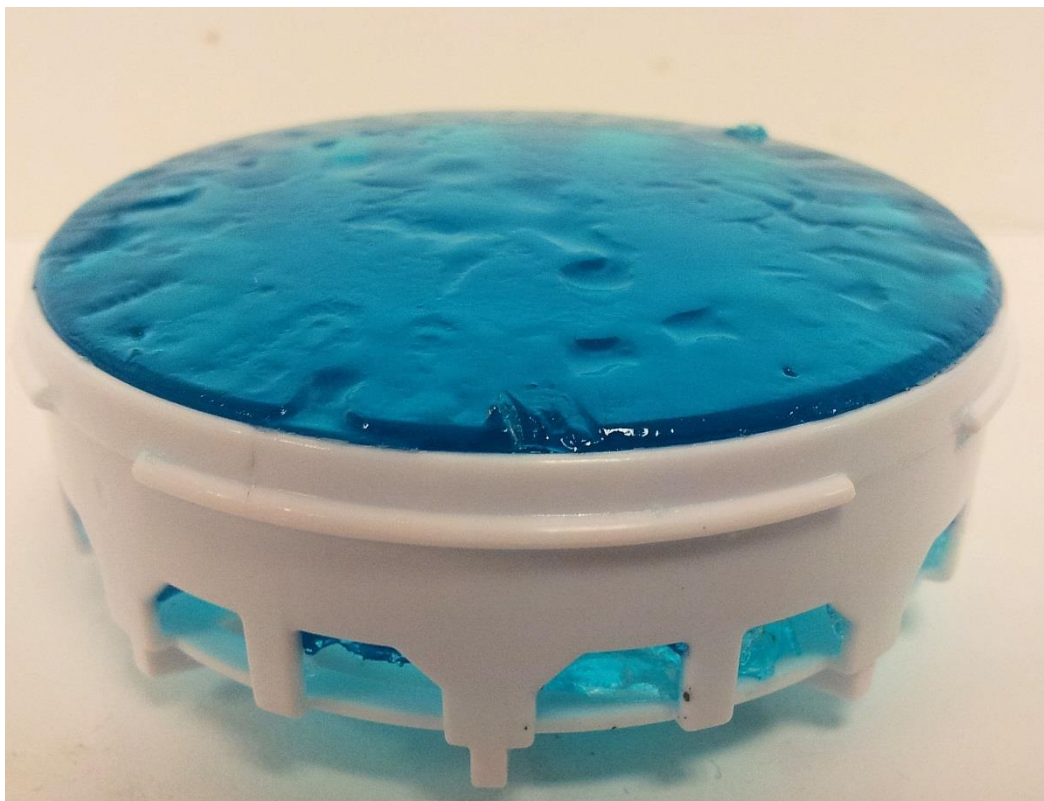
The EnviroSeal units were upgraded to the latest models which had the following upgrades as can be seen in the photos below:

- a new faster draining ElastoSeal trap
- new top sealing system
- no plug opening on top
- BioPur premium gel

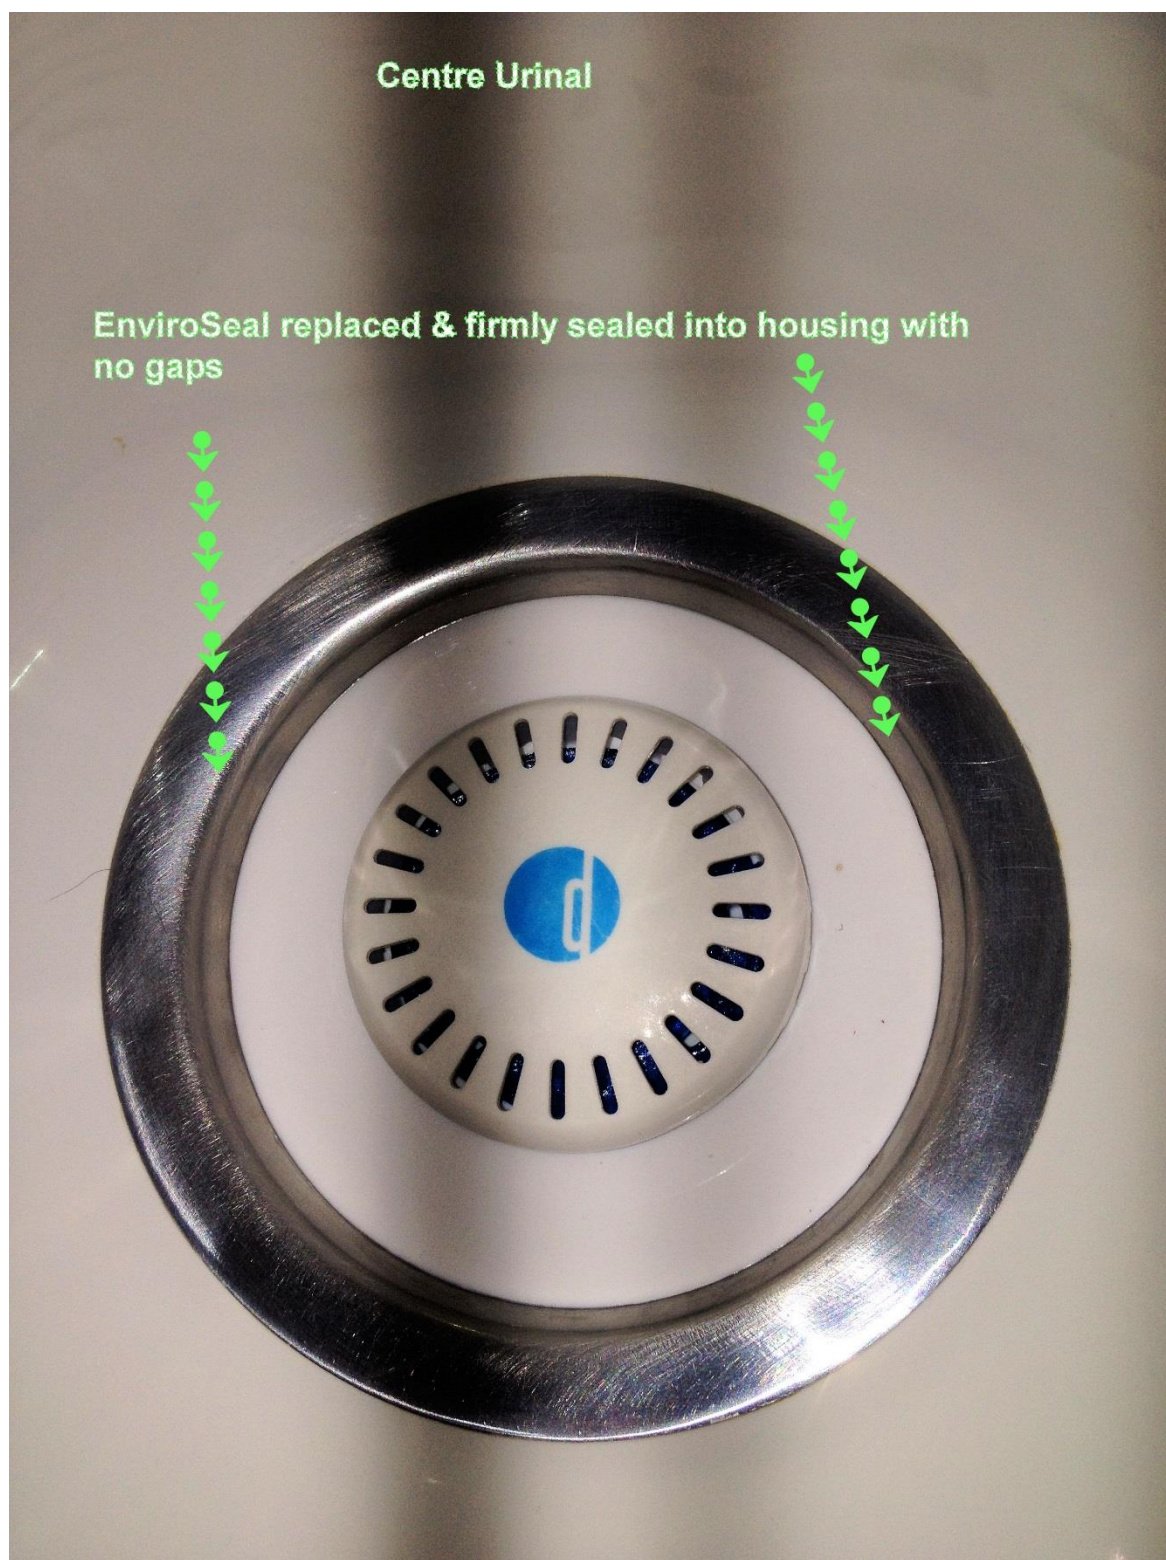
All three urinals were fitted with the upgraded models of the white EnviroSeal operating systems that utilise BioPur premium enzyme gel kits composed of specially formulated bacterial cultures capable of degrading uric acid salts, the leading cause of odours in all urinals. The gel formula kits are longer lasting than the previous tablets with changeover required every 2 months or when all of the gel has dissolved.

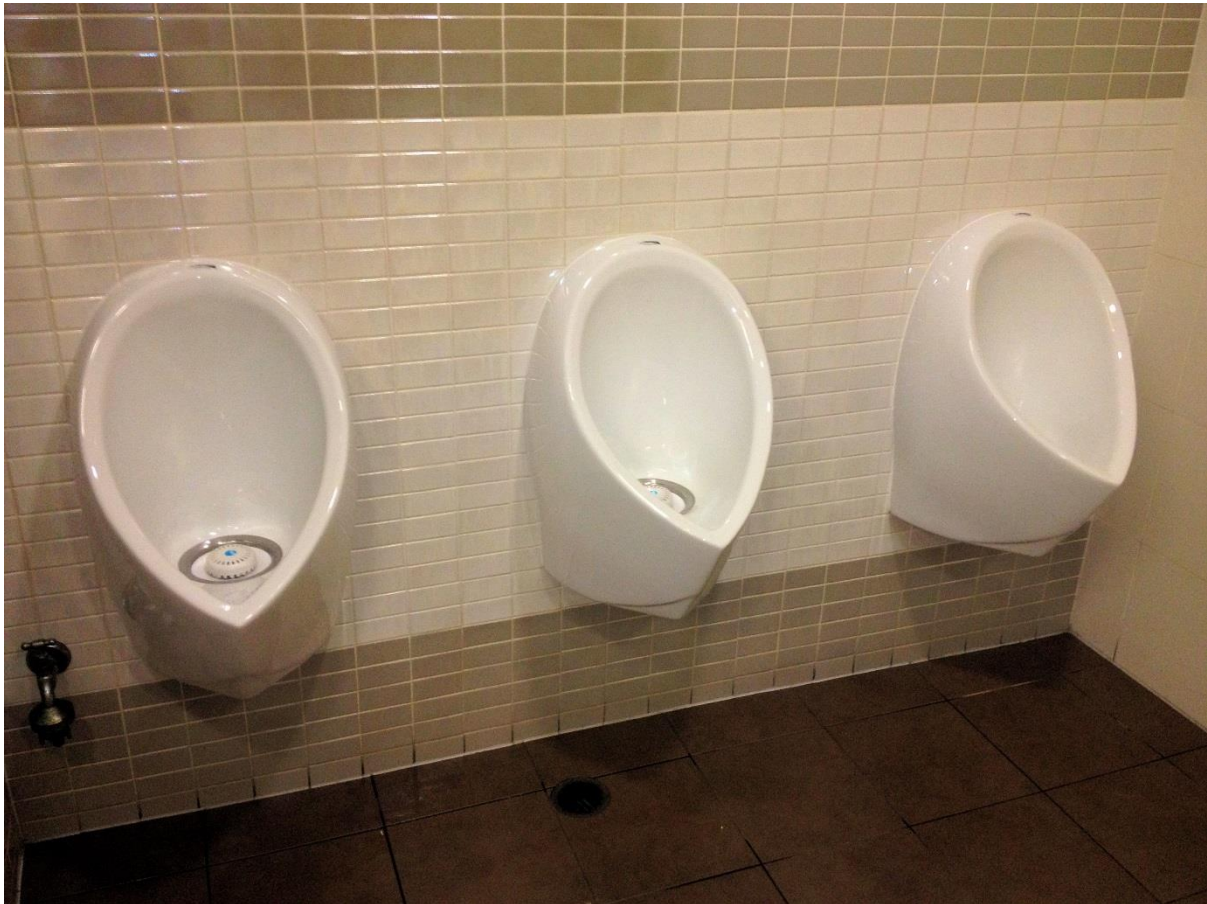
The urinals were then cleaned completely using Enzyme Wizard surface spray and antimicrobial cloths which left the porcelain surface clean and shining as can be seen below.
